Concrete repairs after California tunnel fire

The fast response from the US specialist hydro-demolition contractor and rental company HydroPressure Cleaning (HPC) has contributed to the rapid repairs to a strategic road tunnel in the Newhall Pass on the major I-5 Interstate near Santa Clarita, California about 48km north-west of Los Angeles.

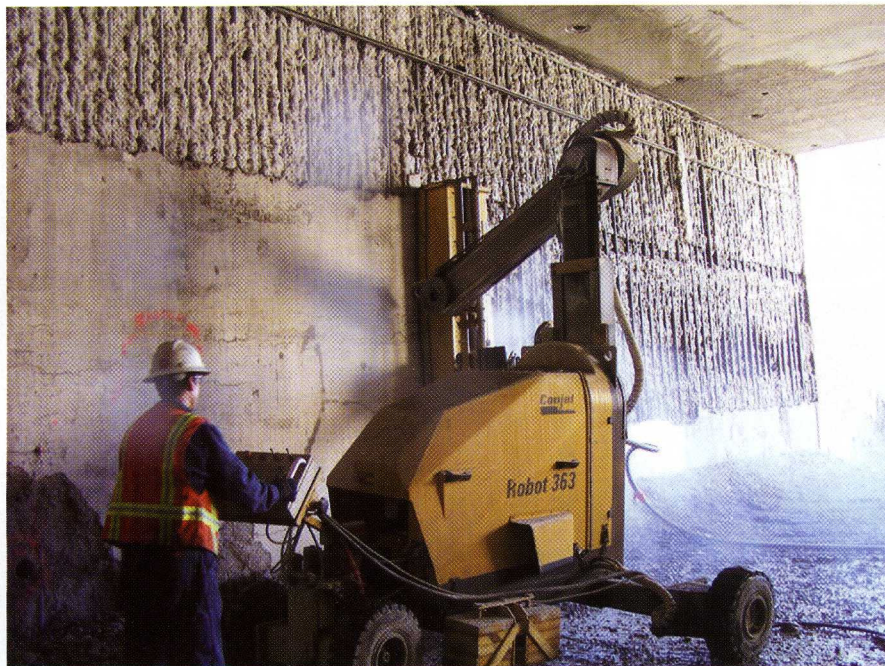
Figure 1: The goal for specialist hydrodemolition contractor on the tunnel walls, which vary in height from about 4.88m to 7.3m, was to cut out damaged concrete to expose to the face side of the reinforcement, but in some areas concrete was selectively removed from behind the reinforcement as a means of inspection.

"We initially used different water pressures of 20,000, 15,000 and 12,000psi (1360, 1020 and 816bar) with the Conjet 322 Robot and our 500hp (373kW) high-pressure pump and removed concrete in 0.6m-wide, 1.5m-high patches every 15m from the walls. This enabled Caltrans engineers to see the differ-

ence in concrete condition and, together with core samples, allowed them to assess and verify the damage and develop the scope of work for the overall repair. We also did a test at 19,000psi (1290bar) using a nozzle with a narrow fan jet pattern instead of the normal straight jetting nozzle. This was great, especially in those areas where they just wanted to roughen up the existing concrete surface to get a bond for the new overlay."
